The History and Conservation of Glass Supported Photographs

Katharine Whitman
Andrew W. Mellon Fellow, fourth cycle
Advanced Residency Program
In Photograph Conservation

August 27, 2007

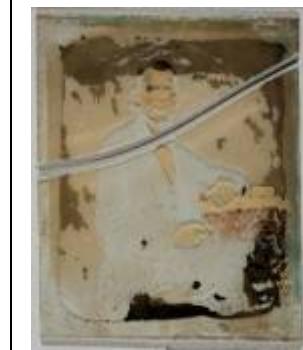
Figure 5

Transgrainular fractures are fractures that travel through the plain of the material, following the path of least resistance (Figure 5). These fractures are the cleanest and easiest to mend.

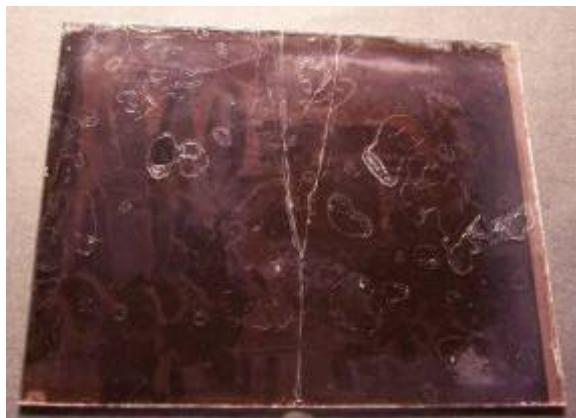
Next, a sample negative was broken and assembled on B-72 coated Mylar on a "Lab-line" slide warmer. A "Taylor" probe thermometer was used to monitor the temperature of the platen. The temperature was slowly raised over a half hour to 40°C and maintained for 15 minutes. The platen was then turned off and the plate was left on the platen to slowly cool. Upon examination it was determined that this method yielded rather large air bubbles (left pic) between the Mylar and the glass. Another plate was repaired using this method, and while the adhesive was still at 40°C it was flipped over and the air bubbles were worked out with a Teflon folder and my fingertips. This yielded a repair with very few air bubbles (right pic), but would not be practical for a larger negative with many fractures.

B-72 film repair, heat alone

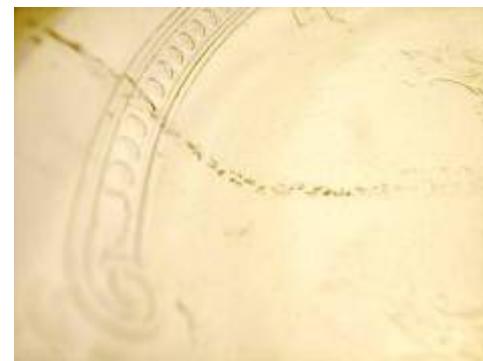
Figure 8

For the purposes of this treatment and the proposed method, Paraloid B-72 has been chosen over Epoxy for its stability and reversibility. The problem with B-72 is that when it is used with a solvent (an aromatic), over time, as the repair cures and the solvent evaporates, “snowflakes” appear in the repair areas (Figure 8), therefore making the adhesive inappropriate for glass plate photograph repair where an invisible, clear repair is desired.

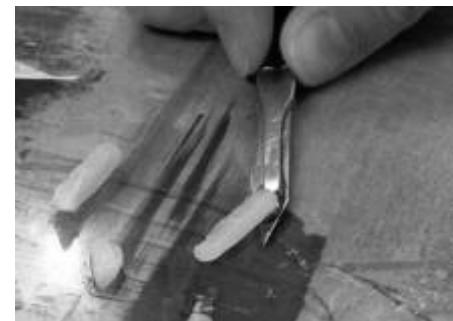
Figure 14. Removal of sticky wax with a heated scalpel.

Once the adhesive was fully cured, the sticky wax was removed with a heated scalpel (Figure 14) and Naphtha swabs. The excess B-72 was removed with B-72 swabs.

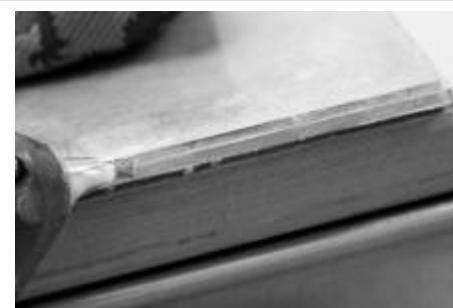
Figure 15. Application of wax seal.

The repaired plate was faced on the emulsion side with a sheet of glass of equal size and sealed around the perimeter with sticky wax (Figure 15), applied with a modified hot glue gun. A barrier of silicone release Mylar[®] was placed between the two sheets of glass to protect the emulsion.

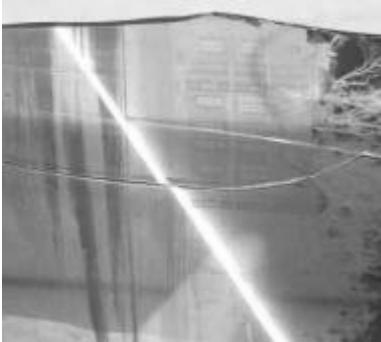
Figure 19. Misaligned shards, note the jagged light line.

Vertical assembly, with the aid of a "*lightline*" will assure the proper placement of the glass shards. A straight line of light, created by a fibre-optic array, will also aid this process greatly. When the light is directed onto the shard interface, *not* at a 90° angle to the interface, any misalignment will be marked by a crooked line (Figure 19). As the pieces are brought into alignment, the *lightline* will become a straight line (Figure 20). A less expensive alternative to the *lightline* could be a flashlight fitted with a snoot that creates a straight line of light: any straight-edged beam of light will suffice.

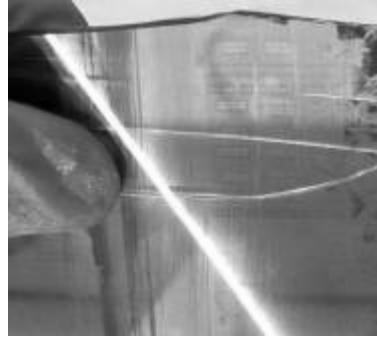
Figure 20. Aligned shards, note the straight light line.

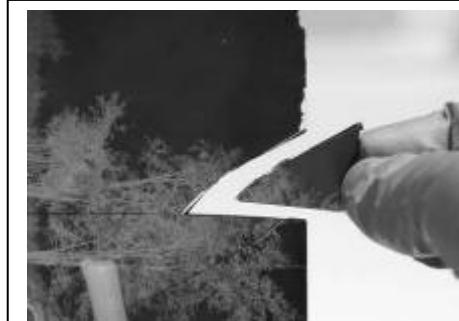
Figure 22. An example of improper assembly of an acute angled shard.

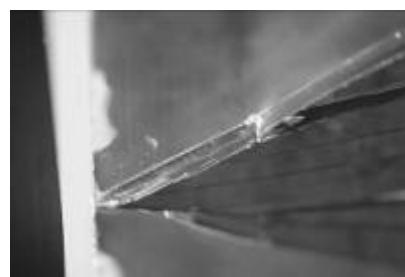
Figures 13, 14, and 15 illustrate the wicking of the adhesive into the shard interfaces. In this treatment, 20% B-72 in toluene was used. Figure 24 is a close-up shot of the shard interface before wicking, lit with the light line on the edge of the plate to illuminate the interior of the plate and highlight the fractures. The wicking occurs very quickly along the interface. Figure 25 illustrates the wicking-in of the B-72: the area that has received the adhesive is to the left of the swab and has become transparent because the refractive index of the B-72 matches that of the glass plate. A fibre optic light trained on the edge of the glass plate will illuminate the fracture lines, allowing for the observation of the wicking adhesive. Figure 26 shows the shard interface with the adhesive fully applied.

Figure 24. Aligned shards before adhesive application.

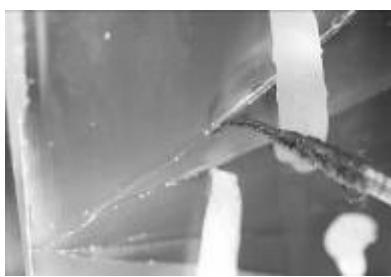
Figure 25. During adhesive application.

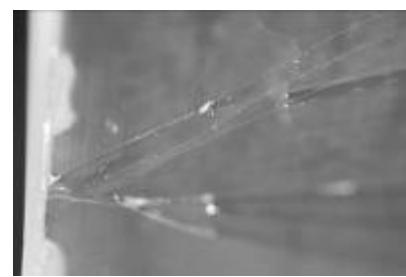
Figure 26. After adhesive application.

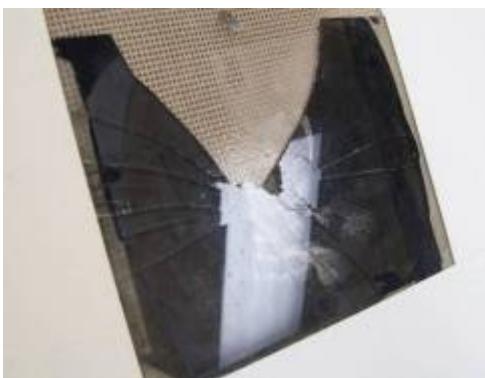
Figure 29

The shards were assembled on the stage. Precise alignment of the shards was not done until they were all on the stage. The impact shattering nature of the break created many tiny fragments that radiated out from the center of the impact area: shards had to be manipulated during assembly and for ease of assembly the tacking of the pieces was left until just prior to adhesive application. Figure 30 illustrates compete assembly of the shards, with the ceiling light reflected in the surface to show their misalignment.

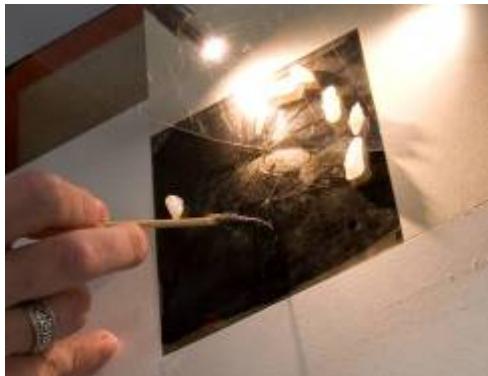
Figure 31

Once stabilized, 20% B-72 in Toluene was wicked into the shard interfaces with a steel wool swab (Figure 31). After allowing the adhesive to set for 24 hours, the plate was inverted and it was discovered that adhesive had migrated onto the binder side of the plate in the area of the plate where the shards were the smallest. It was very easy for too much adhesive to be applied in this area (Figure 32). The excess adhesive was removed by dabbing the area with acetone cotton swabs, and the adhesive was left to cure for two weeks.

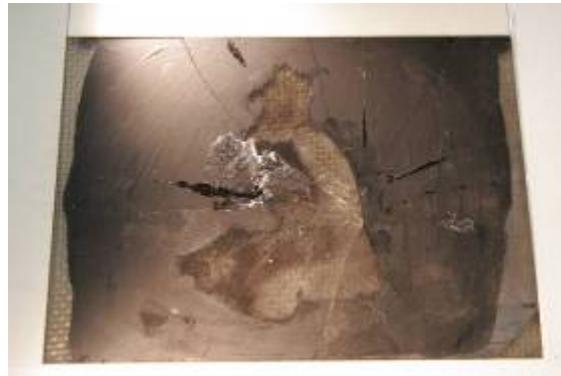
Figure 32

The current accepted method of assembling broken glass plate negatives is to apply the adhesive to the shard interface in a series of small drops, then place the shards into contact on an inclined surface. One of the problems with this method of assembling plates is that a lot of excess adhesive is wasted and travels onto the binder side of the plate (caused by capillary action between the Mylar and the plate), requiring clean up with solvents. The use of the Silpat[®] mitigates some of that problem, unless there are many small shards in the repair (Figure 32).

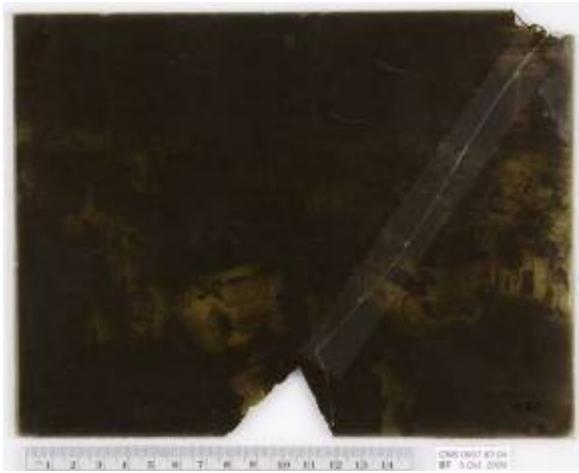
Before

Gelatine silver glass plate negative on glass 2mm thick.

Removal of pressure sensitive tape from the emulsion side of the plate. The broken glass was repaired with Epotek 301 Epoxy. It was decided not to fill the losses and to create a form filling secondary support of matboard.

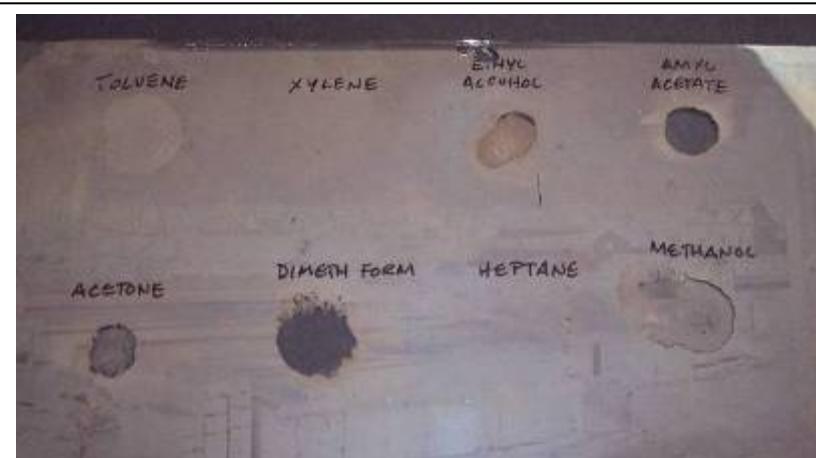
Process identification is extremely important before undertaking any treatments: even those as simple as surface cleaning. Collodion binders are very sensitive to solvents. Figure 34 is an example of a collodion negative that has been used to determine its sensitivity to a variety of solvents. The two solvents tested that did not seem to affect the binder were Xylene and Heptane. This information should be taken with a grain of salt: no two collodion negatives will necessarily react to a solvent the

same way. There were a wide variety of varnishes available for collodion negatives and without spot-testing one cannot be sure how the varnish and collodion binder will react. It is best to limit the surface cleaning of a collodion negative to a soft dry brush.

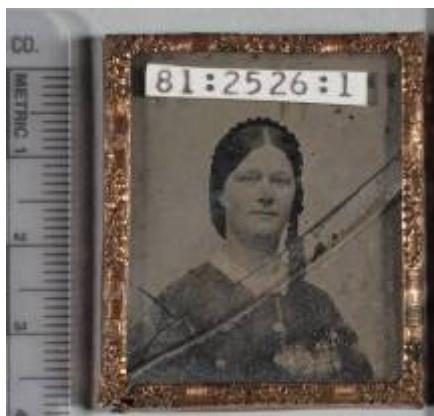
Figure 35

Before

Housing: The preserver is very tarnished and broken through in the bottom left corner. The cover glass is broken diagonally from the bottom left corner to the central right edge. The rest of the case is missing.

Image Plate: The image plate is broken diagonally, consistent with the cover glass break, and in the bottom left corner. The image binder is flaking with losses along the break lines. The binder is bubbling with losses to the right of the sitter's neck. There are dusty accretions along the bottom edge from the center to the right corner. The varnish is clouded slightly over the sitter's face and in the bottom right corner.

The plate was assembled and mended with Epotek 301 epoxy and image losses were inpainted. A custom made housing was created that allows viewing of both sides of the plate.

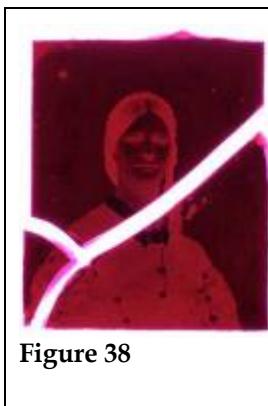
Figure 38

A sixteenth plate red ruby glass ambrotype (Figure 38), with tinting on the sitter's cheeks. With cover glass, preserver, and brass window mat present behind the image plate (Figure 39). The case is missing. Archives sticker on the verso of the cover glass: typed "81:2526:1".

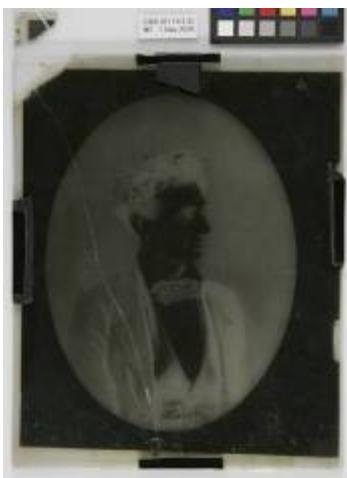
Before

Previous Treatment: The negative has broken and been stabilized with yellowed pressure-sensitive tape in the TRC and along the BE, and then sandwiched between two sheets of glass measuring approximately 25.5 x 20.4 x 0.2 cm. The sandwich has been secured with black paper tape that has been over-taped with black plastic tape in the central area of all four edges. Each piece of tape is approximately 6 cm long. In

The negative has broken diagonally from the TLC to the BCE (please see photodocumentation), and the TL corner has also broken off. There are two small shards from the TL corner: one piece has the letters "B.A." handwritten in black ink along the TE, and the second is slightly smaller. There are minor losses along the broken edges and two areas of complete loss in the TL corner. There is minor soiling and fingerprints over all the pieces. There is adhesive residue present from the pressure sensitive tape that has cross-linked and become brittle (see previous treatment). There are some minor abrasions overall. There is insect frass between the sheets of repair glass at the TL corner (Figure 43). There is glass deterioration occurring where the object glass has been in contact with the repair glass, in the form of small star-like crystals (Figure 44). There are long bubbles in the glass associated with the manufacturing process.

The plate was removed from the glass sandwich housing and the double-stick tape removed in an acetone bath. Remaining carrier and adhesive was removed with acetone swabs. The plate was then assembled vertically and mended with 25% B-72 in toluene.

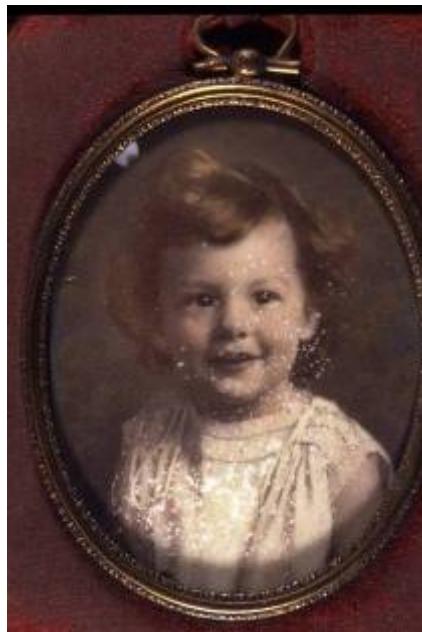
Before

An oval, hand-colored Opaltype, circa 1925, with severely cracking gelatin binder and small losses.

Image Plate: The gelatin binder layer and pigment layer is severely embrittled and cracked with widespread flaking throughout the plate. The flaking is particularly severe in the lighter areas where there is less pigment such as the face, arms and dress

with numerous small areas of loss. There is a large area of loss of emulsion/pigment located in upper left of image near top of child's head. Fibres from the degraded velvet tray pad are present throughout emulsion/pigment layer.

This photograph was surface cleaned, flaking emulsion was consolidated with B-72 in Toluene and Xylenes and the housing was repaired.

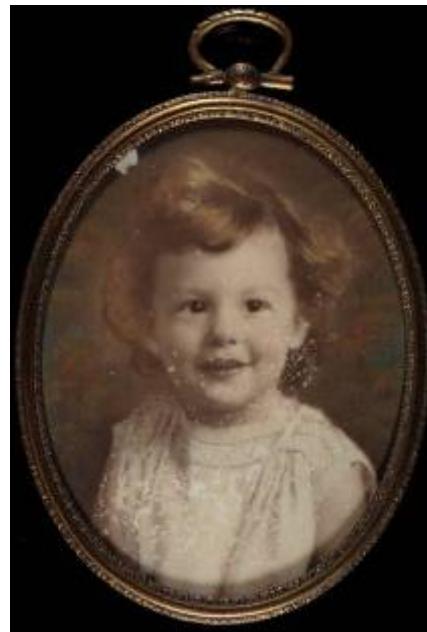
After

The image is now stabilized and secured. The loss in the image was left untouched. It is recommended to have digital restored reproductions than to add modern materials to the original just for aesthetic reason.

1. The surface dirt and loose velvet fibers were carefully picked away with a pair of small tweezers with a sticky tip under microscope.
2. The flaking emulsion was locally consolidated with 5% Paraloid B-72 in toluene and burnished slightly with a Teflon bone folder to encourage the lifted emulsion to glue down to the support. Again, this step was carried out under microscope with custom designed micro tool to deliver the consolidant precisely to the problematic emulsion. The consolidation was repeated again until all flaking emulsion stabilized.

3. The entire image was varnished with 10% Paraloid B-72 in xylenes, delivered with a fine air sprayer. This varnish was mixed with Polydispersion D for the image to retain matte surface.
4. Three small pieces of velvet strips of the similar color to the velvet backing on the back were attached to the inner wall of the brass ring to ensure that the image package and the velvet backing fit snuggly into the ring.
5. The broken rail on the top of the case was adhered together with diluted hide glue and clamped for the adhesive to set for a day.

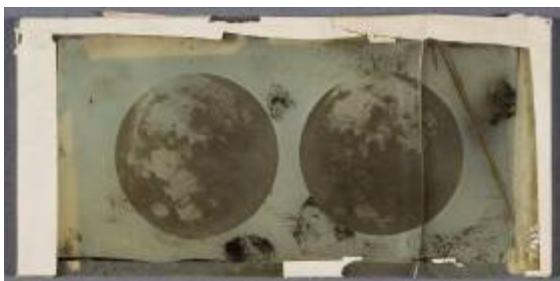
Before

A stereo-transparency on curved glass, that has broken into three pieces.

of breakage. There are two cracks on the right side of the positive running from the top to the bottom edge, resulting in a loose triangular piece of the positive, and two pieces still held in place by the binding tape. The loose triangular piece has a hairline crack bisecting the most acute angle. There is a brown discoloration at the top of the hairline crack and on either side of the crack that does not go through the image of the moon.

The stereo-transparency was stabilized at the edges by applying dots of Epo-tek 301 epoxy. A custom cradle was made within the housing to support the curved glass.

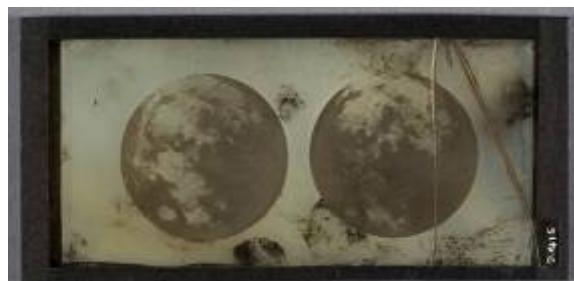
After

4. A curved support was made for the positive using strips of 4-ply mat board along the edges and tacked in place with Acryloid B-72.
5. The repaired collodion positive and its diffusing glass were bound with Filmoplast P-90 toned black with Sumi ink.

6. A U-shaped cradle made from 2 pieces of 8-ply mat board was cut to fit into the existing GEH archive sleeve and prevent the collodion positive from being compressed when stored in the drawer with other glass plates.

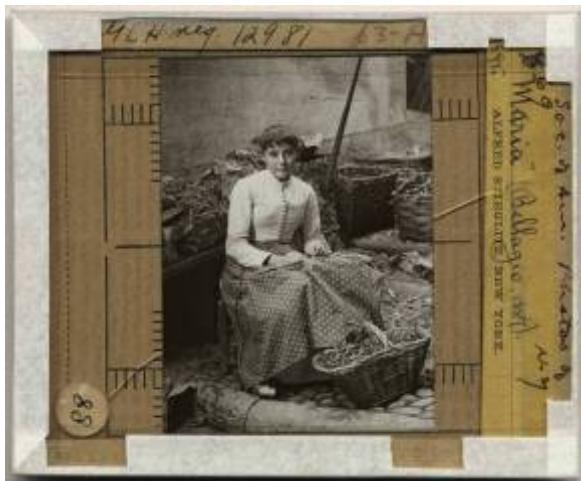
Before

A lantern slide by Alfred Stieglitz with broken cover glass and loss of the original binding tape.

Replacement of a broken cover glass and restoration of the original binding tapes with toned P-90.
